Technical Service Bulletin

37 Vehicle electronics malfunction message, DTC B116229 is stored in the steering wheel or vehicle electronics module

37 20 95 2047609/4 April 10, 2020. Supersedes Technical Service Bulletin Group 34 number 20-44 dated March 5, 2020 for reasons listed below.

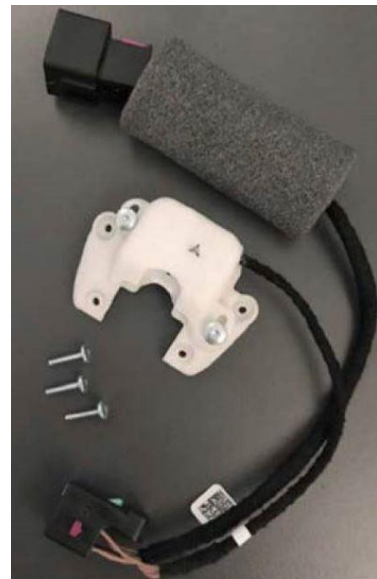
Figure 1. New micro switch module.

If the customer has the above condition and the DTC B116229 is stored in the steering wheel electronics module, J527 (address word 0016) or the vehicle central electrical system module J519 (address word 0009), then install the new externally mounted micro switch module and selector lever handle sleeve per the instructions below (Figure 1).

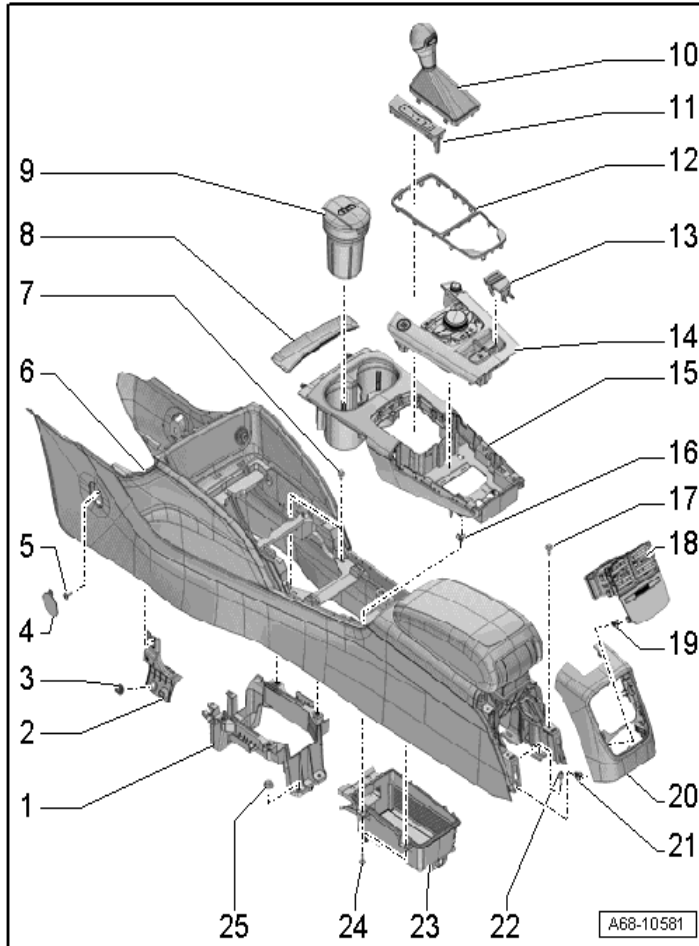
Figure 2. Center console overview.

1. Set the parking brake. Remove the shift knob with the boot (Position 10), selector lever transmission range position display unit Y26 (Position 11), and center console insert (Position 15) per the repair manual instruction (Figure 2).

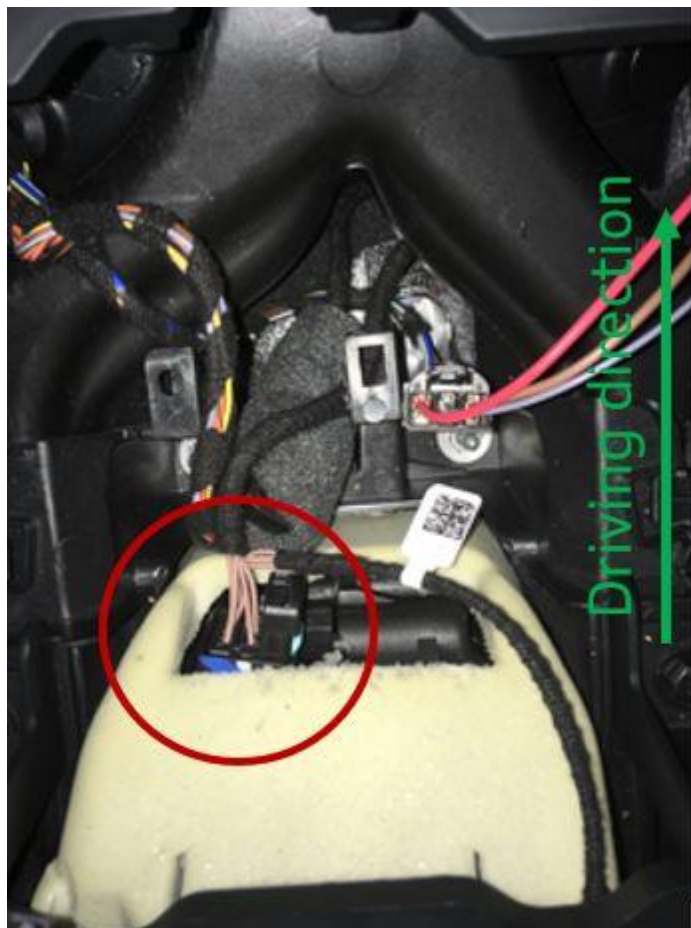
Figure 3. The electrical connection of the selector lever control module.

2. Disconnect the electrical connector from the selector lever control module (Figure 3).

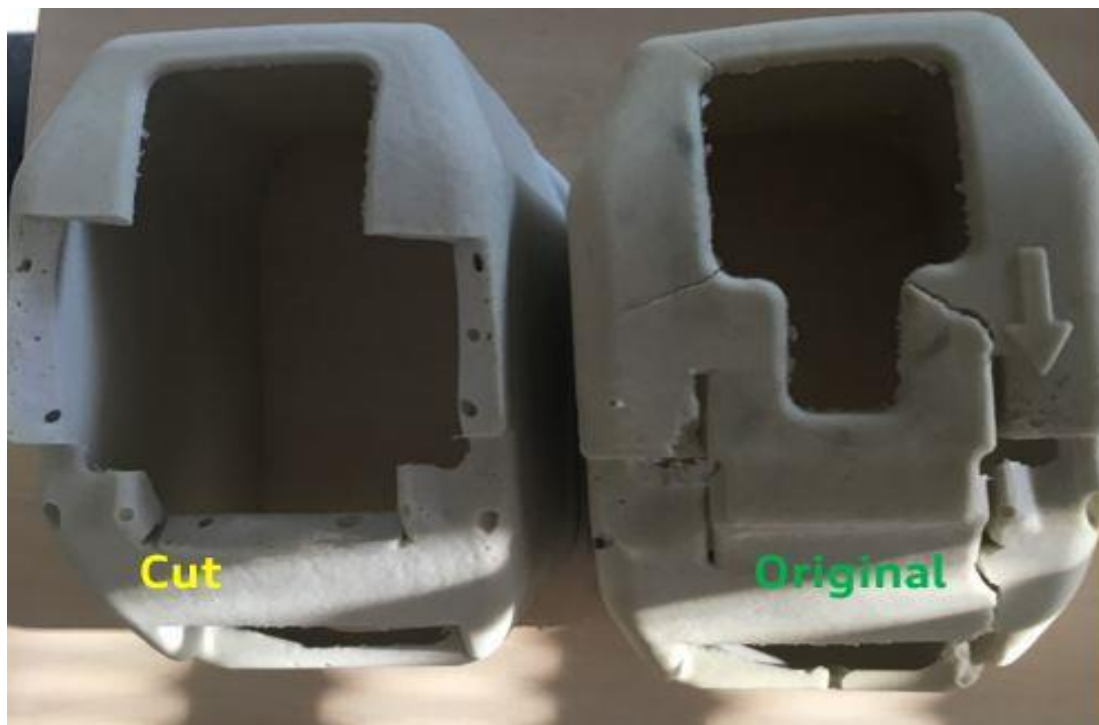
Figure 4. Modified and original insulation.

3. Carefully remove the foam insulation from the selector lever control module and carefully modify the insulation as shown below with scissors or a sharp knife (Figure 4 and Figure 5).

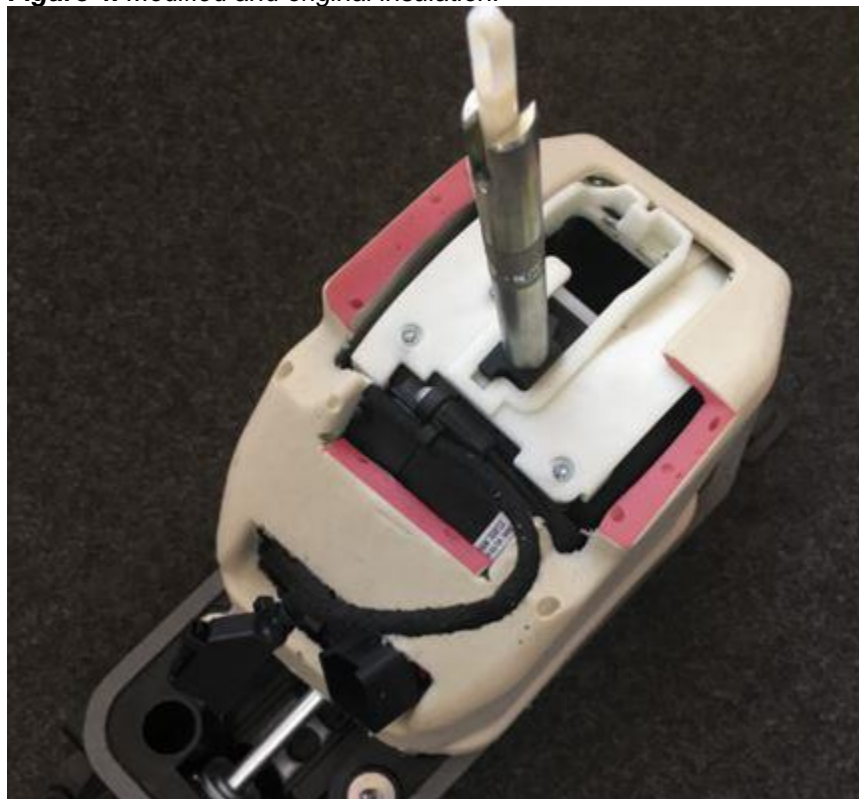
Figure 5. Example of modified insulation installed on a shifter housing.

- Carefully reinstall the foam insulation as shown above (Figure 5).

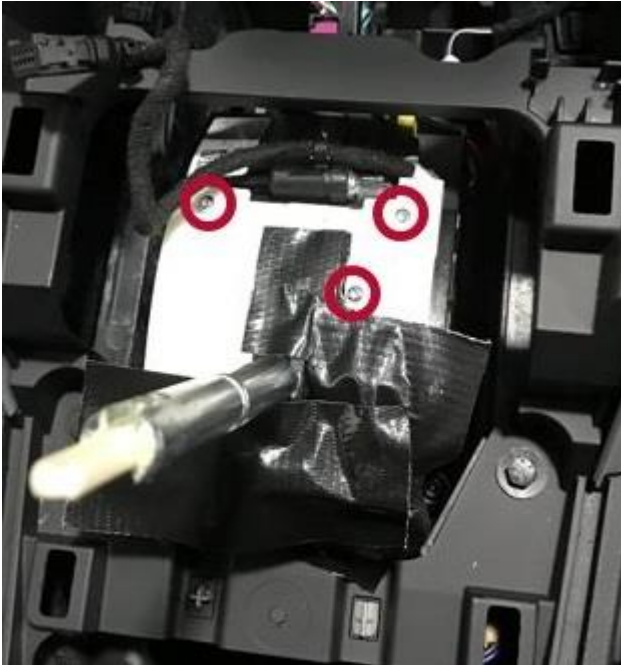
Figure 6. The tape covering shift gate and screw locations.

- Tape the opening of the shift gate to protect the module from screws or tools falling into the control module. Tape the opening as shown below while leaving the screws (circled in red) uncovered (Figure 6).

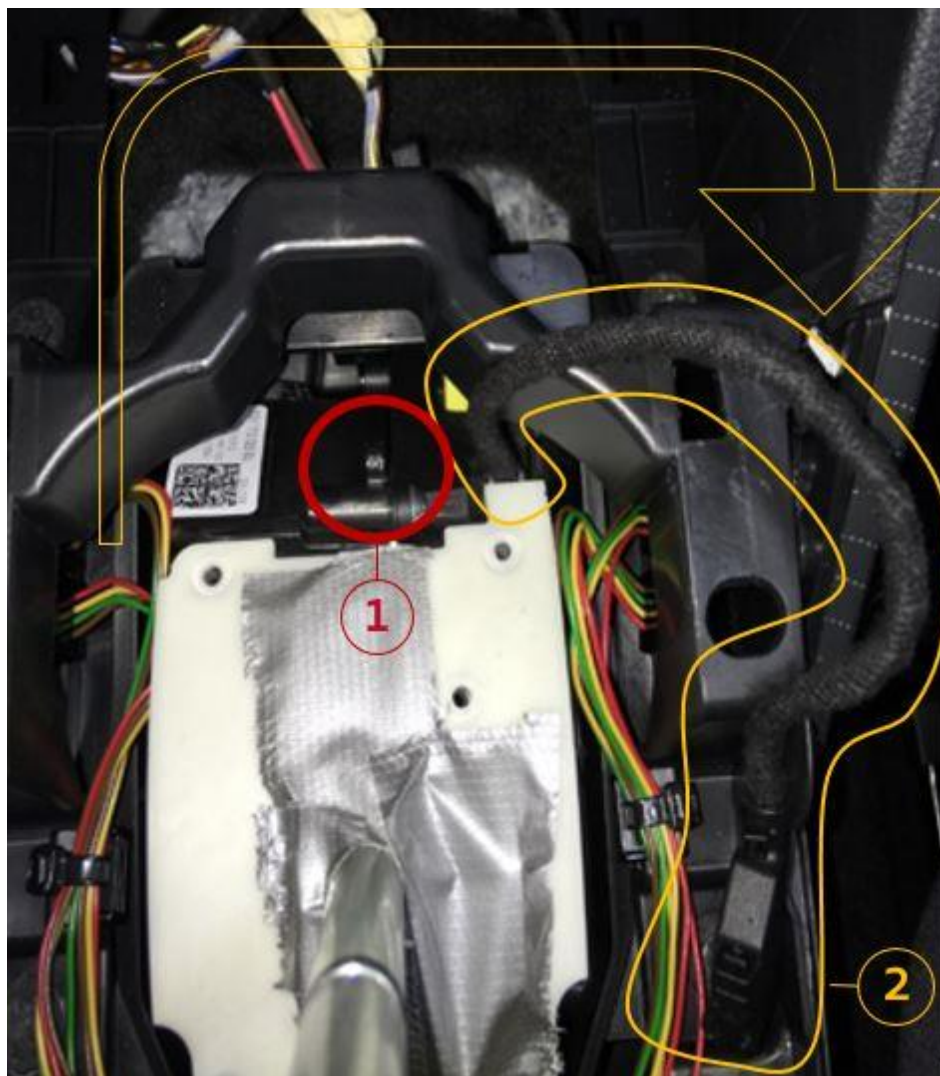
Figure 7. Display unit Y26 harness repositioning.

6. Remove the T-9 screws show above (Figure 6) circled in red. You may discard these screws, as they will not be reused. Then move the wiring of the selector lever transmission range position display unit Y26 out of the way to the passenger side as shown below (Figure 7). Remove the harness from the retention clip (Position 1) and set the harness to the side as shown in yellow (Position 2).

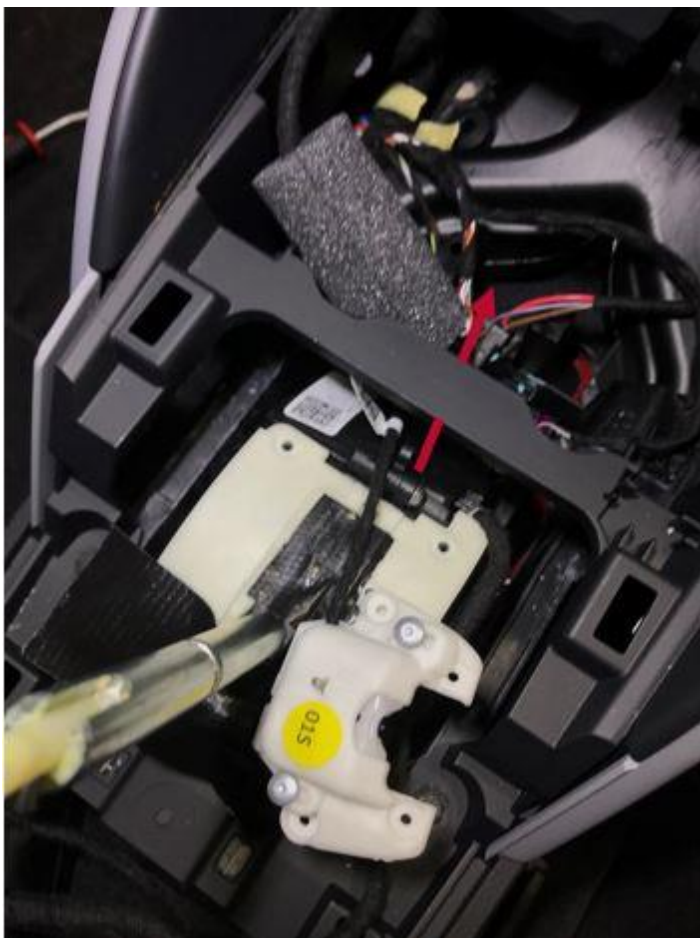
Figure 8. Wiring harness run under the crosspiece.

7. Lead the Y cable wiring harness of the new micro switch module under the crosspiece and on top of the foam insulation (Figure 8).

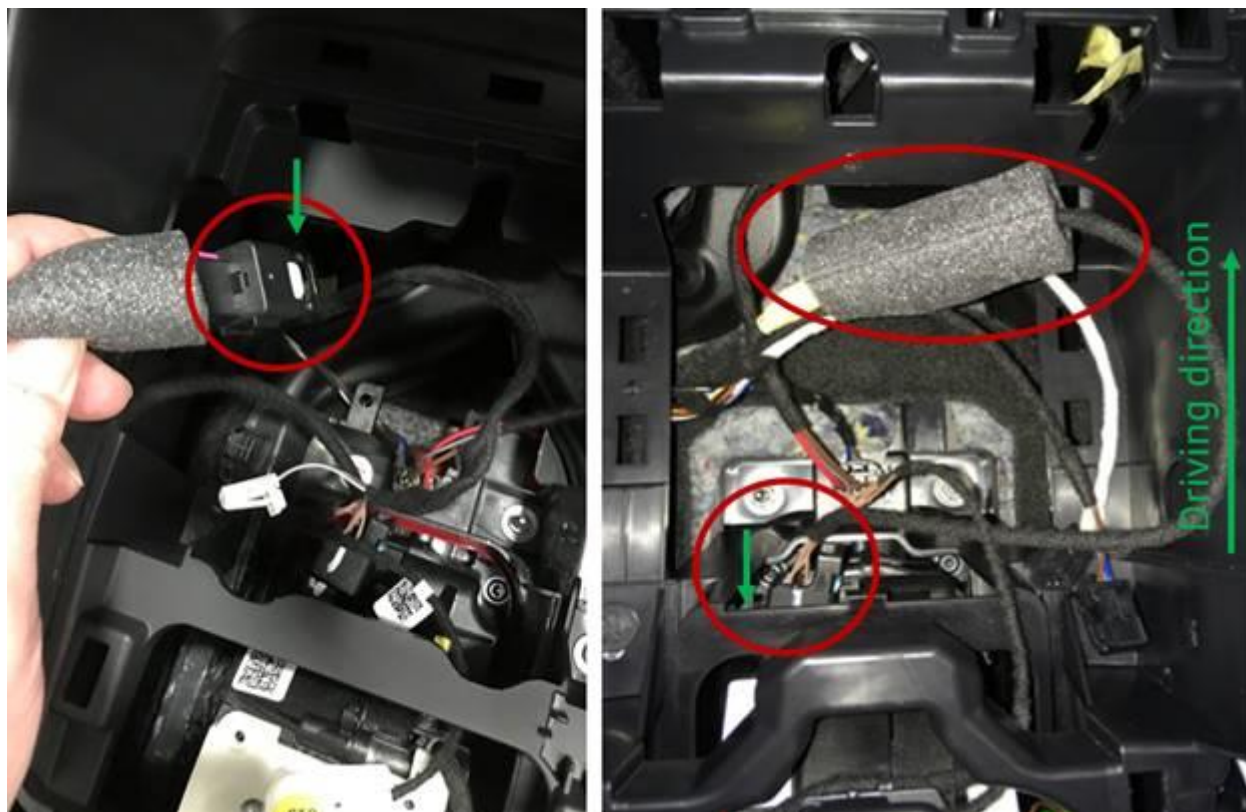
Figure 9. Wiring connections.

8. Plug one end of the Y cable into the selector lever control module and the other end into the existing vehicle harness. Pull the foam cover over the connection to the vehicle harness.

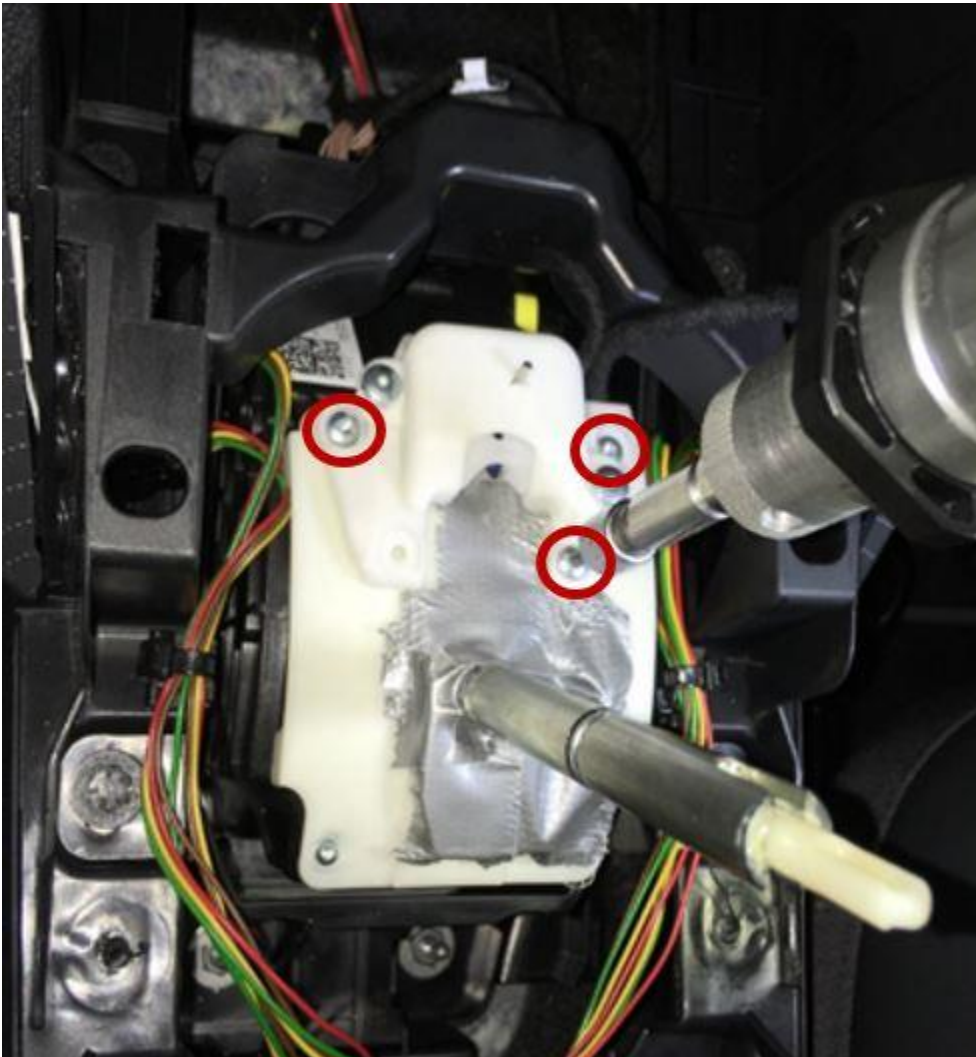
Figure 10. *Installing the microswitch module.*

9. Install the microswitch module to the selector using the new longer T-9 screws included in the repair kit. After all three screws have been started, remove any of the tape that might interfere with the base of the microswitch module. Torque the screws to 1.0 Nm and remove the remaining tape from the shift gate (Figure 10).

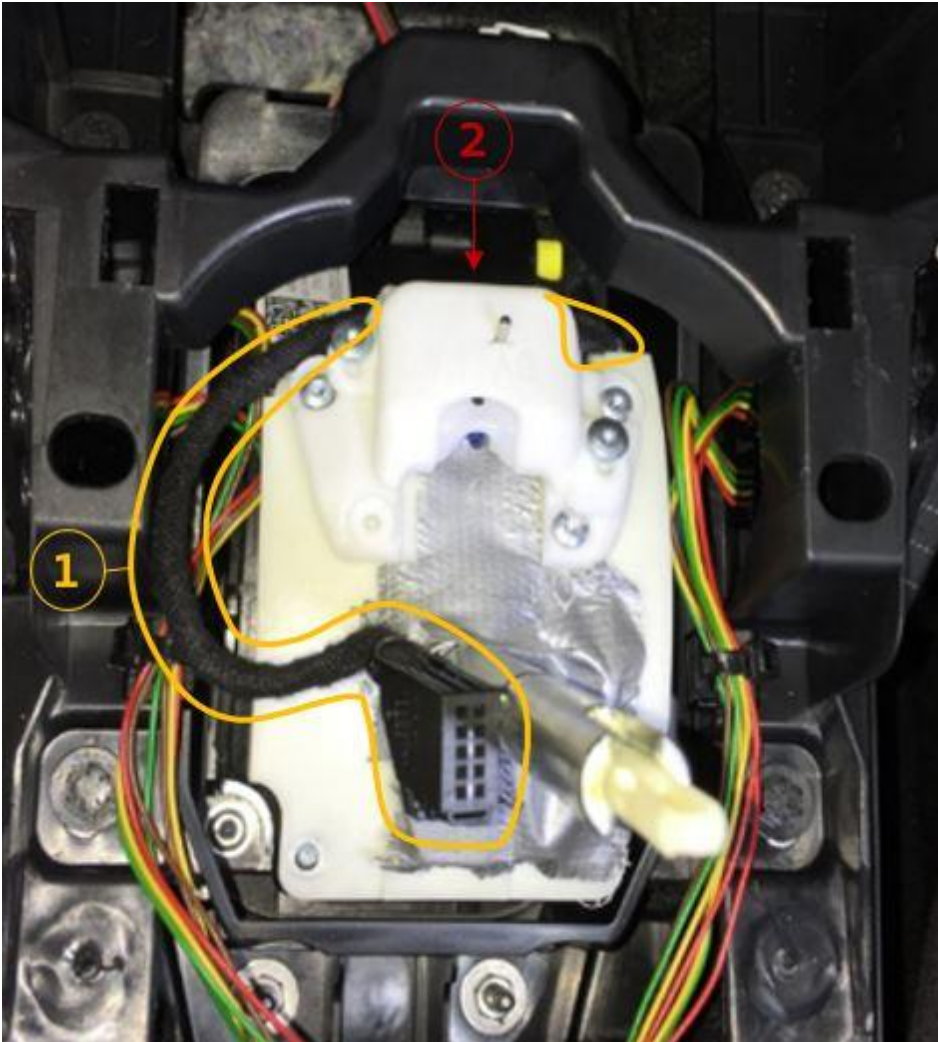
Figure 11. Display unit Y26 harness.

10. As shown below route the wiring of the selector lever transmission range position display unit Y26 back to the driver's side of the shift selector (Position 1) and secure harness back to the selector lever control module (Position 2) (Figure 11).

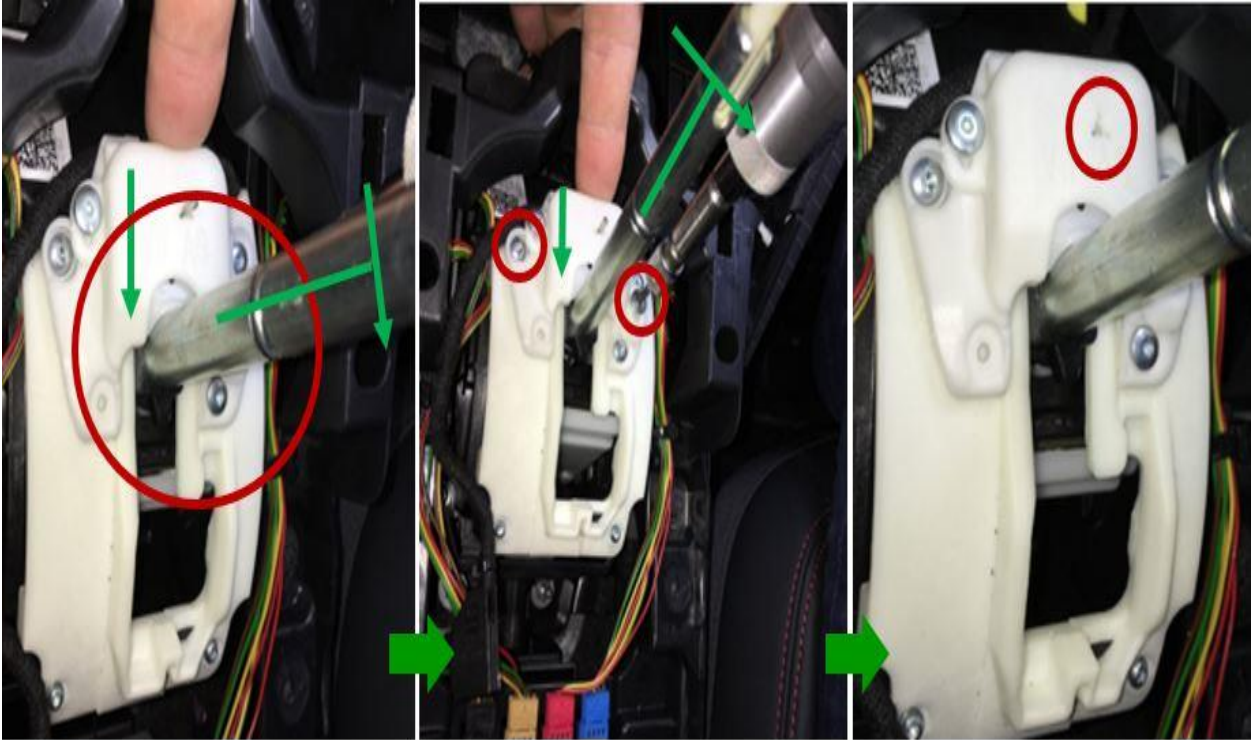
Figure 12. *Microswitch module adjustment.*

11. Place the selector lever into the “Park” position and adjust the microswitch module as shown below (Figure 12).
 - Lightly pull the selector lever toward the reverse lockout (the release mechanism must not be operated) and hold in this position.
 - Move the adjustable slide of the microswitch module until it is completely touching the selector lever and tighten the two T-9 screws to 1.0 Nm.
 - Carefully remove the locking pin from the microswitch module making sure you do not drop it into the open shift gate. Save the locking pin until the repair is complete as it may be needed for readjustment.

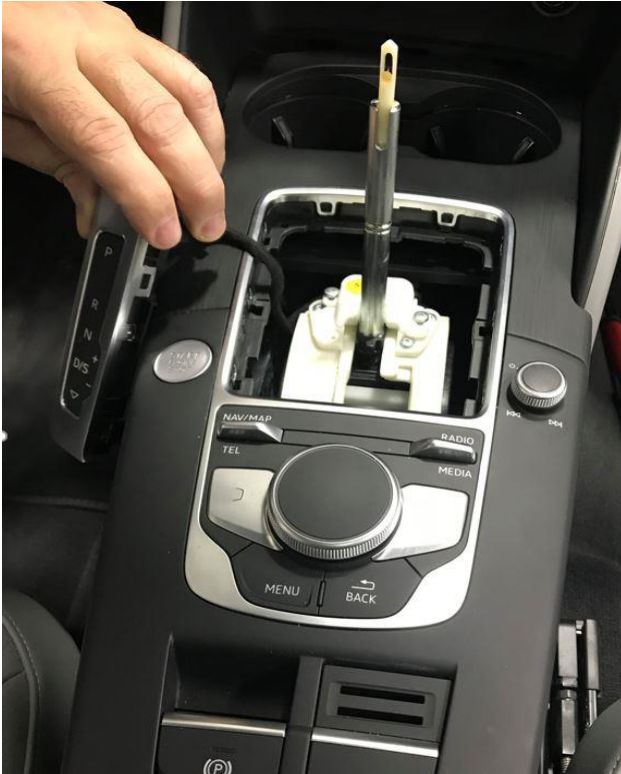
Figure 13. Console insert installed.

12. Reinstall the center console insert. Make sure all wiring has been routed correctly and cannot be damaged by sharp edges. Plug in display unit Y26 but do not install it in the console yet (Figure 13).

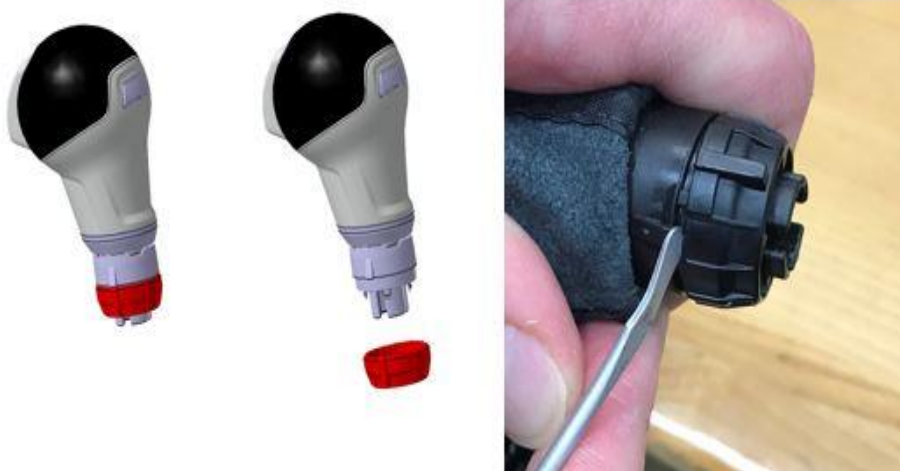
Figure 14. Locking collar removing.

13. Install the new selector lever handle sleeve on the bottom of the shift knob. The original locking collar can be removed with a small screwdriver or micro pry bar (Figure 14). The new selector lever handle sleeve snaps in place of the old collar (Figure 15) and operates with the same locking function while protecting the microswitch module from interference with the shift boot.

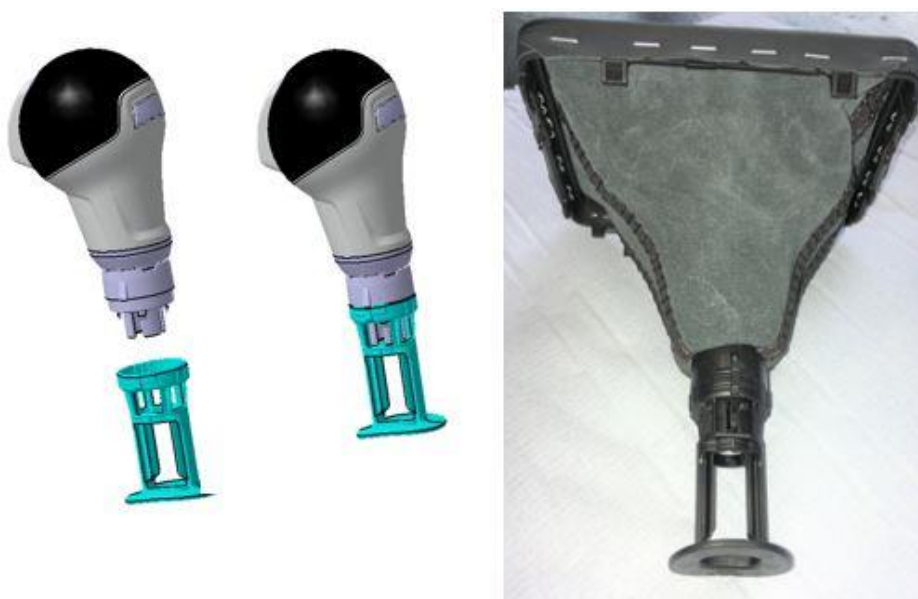
Figure 15. Selector lever handle sleeve.
